# **Strengthening of an Impacted PC Girder on Bridge A10062, St. Louis County, Missouri**

RI 99-041

November, 2001

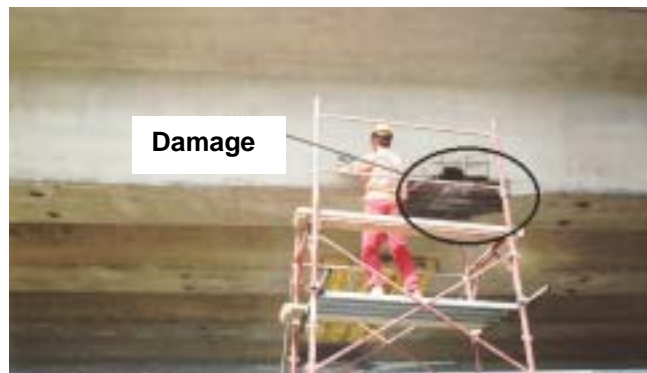
Figure 1.1. Girder Damage due to Vehicular Impact

Figure 1.1 illustrates the effect of a vehicular impact on the four girders of the bridge overpass on highway Appia near Terracina, Rome (Nanni 1997). This is a short bridge, 34.48 ft (10.5 m) in span, made of four prestressed concrete girders having cross sectional dimensions of 3.28 by 4.92 ft (1.0 by 1.5 m). The conventional reinforcement (prestressing tendons and reinforcing bars) is clearly visible in the photograph after the loose concrete was removed.

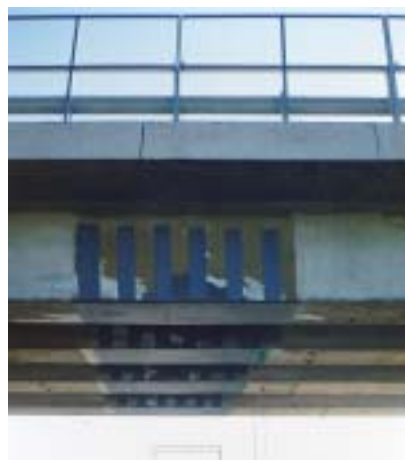
Figure 1.2. Pattern of CFRP Strips

The concrete cross section was restored with non-shrink mortar and, after surface preparation, CFRP sheets were adhered as shown in Figure 1.2. The objective of the CFRP strengthening was to make up for the loss of prestress. For each beam, three sheets, 1.08 ft (0.33 m) wide and 9.84 ft (3.0 m) long, were bonded to the soffit ( $0^\circ$  fiber direction), and four strips, 0.52 ft (0.16 m) wide and 9.84 ft (3.0 m) long, were wrapped around the three sides ( $90^\circ$  fiber direction). The total amount of CFRP material used was approximately  $215.27 \text{ ft}^2$  ( $20 \text{ m}^2$ ).

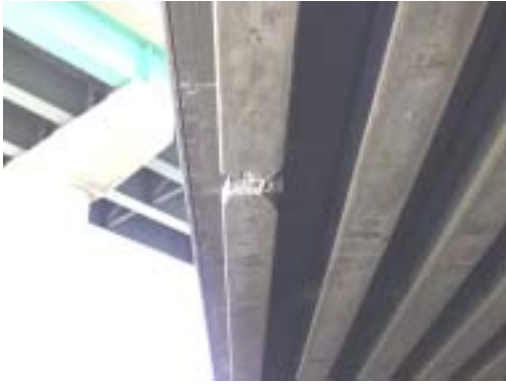
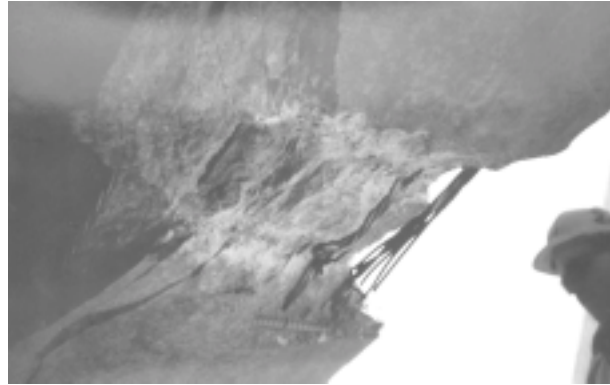
Figure 1.3. Fractured Tendons after the Removal of the Damaged Concrete

Bridge A10062 is located at the interchange of the Interstates 44 and 270 in St. Louis County, Missouri, USA. Elevation and plan details are shown in Appendix A. The bridge has a relatively low roadway clearance of 14.ft-10 in. (4.52 m), and it was impact-damaged by an overheight truck in one of its exterior PC girders. Removal of the loose concrete showed that two prestressing tendons were fractured due to the impact (see Figure 1.3).

(a) Overall View of the Damage

(b) Fractured Prestressing Tendons

The rehabilitation of this impact-damaged girder called for concrete repair and application of CFRP laminates. The flexural strengthening consisted of two 18 in. (45.7cm) wide plies with lengths of 9 ft-4 in. and 10 ft-8 in. (285 and 325 cm), respectively, applied to the bottom of the girder with fibers aligned along its longitudinal axis. The double ply-laminate was centered over the damaged area (see Figure 3.2). Sixteen strips, 4 in. (10.2 cm) wide and spaced at 8 in. (20.4 cm) on centers, were then U-wrapped around the bulb of the girder over the previous installation (see Figure 3.3). The purpose of the U-wrap is to prevent the delamination of the FRP plies applied to the bottom surface of the girder. After repair, the factored capacity of the girder was computed to be  $\phi M_{n(\text{repaired})} = 2223 \text{ ft-k (3012 kN-m)}$ , which basically matches the original capacity. Appendix B shows the supporting calculations for the flexural capacity of the original, damaged and repaired sections. The calculations were carried out in U.S customary units.

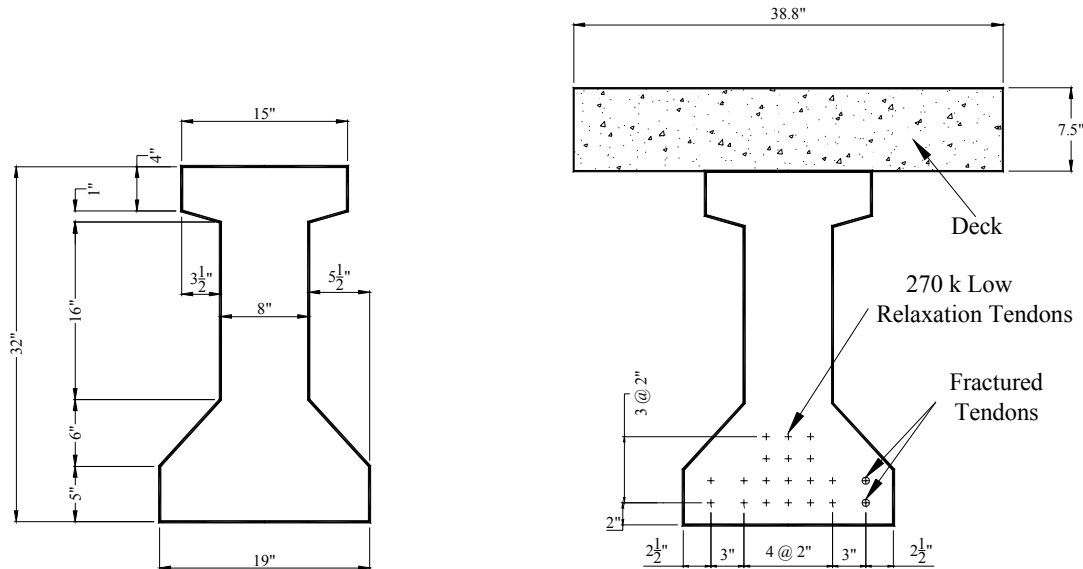
Figure 2.1. Girder Dimensions and Prestressing Details

The damaged girder was prestressed by 20 low-relaxation 7-wire steel strands with a tensile strength of 270 ksi (1862 MPa). According to a MoDOT requirements the effective slab thickness was considered as 7.5 in. Following AASHTO provisions (Sections 9.8.1 and 8.10.1), the effective flange width was estimated as 47.5 in. Since the existing deck and the PC girder have different compressive concrete strengths, the effective width was modified by multiplying it by the modular ratio of elasticity  $n = E_{ct}/E_c$  ( $E_{ct}$  = modulus of the topping concrete and  $E_c$  = modulus of the precast concrete). For an  $n$ -value equal to 0.82, the modified flange width was 38.8 in. The modulus of elasticity of concrete can be estimated as  $E_c = w_c^{1.5} 33\sqrt{f'_c}$ , where  $w_c$  is the weight of concrete (for calculation purposes, it was considered to be 150 lb/ft<sup>3</sup> in both topping and precast concrete). The cross section of the damaged girder and prestressing details are shown in Fig. 2.1. Material properties used in the analysis are shown in Table 2.1.

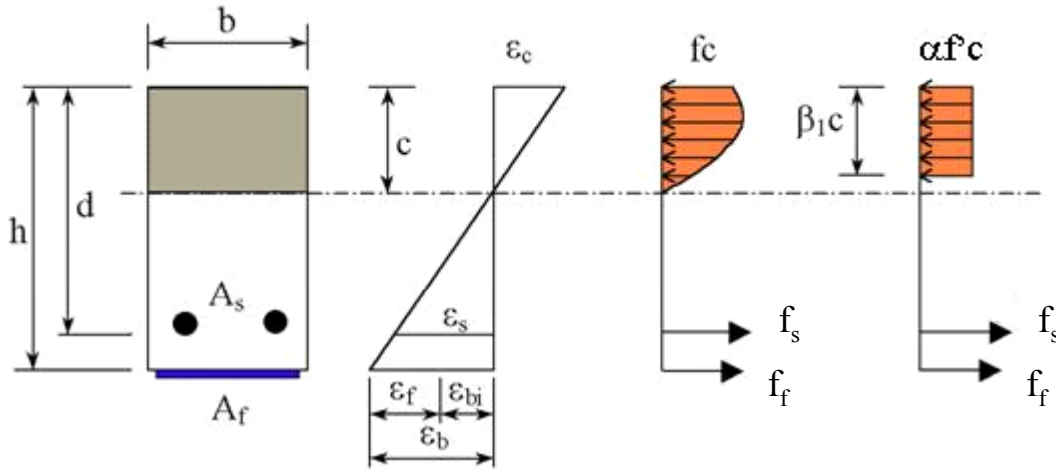
Figure 3.1. Strain and Stress Distribution in a RC Section at Ultimate

The ultimate limit state analysis calculates the capacity of the section at failure by combining force equilibrium, strain compatibility, and the constitutive laws of the materials. As an example the stress and strain distributions at ultimate for a rectangular cross section are illustrated in Figure 3.1. The non-linear stress strain behavior of concrete may be replaced for computational ease by a rectangular stress block with dimensions  $\alpha f'_c$  by  $\beta_1 c$ .

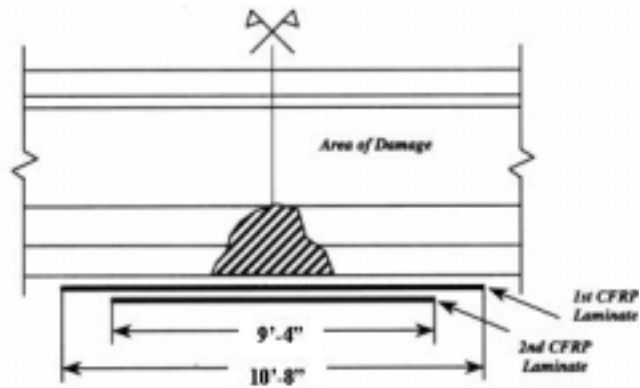
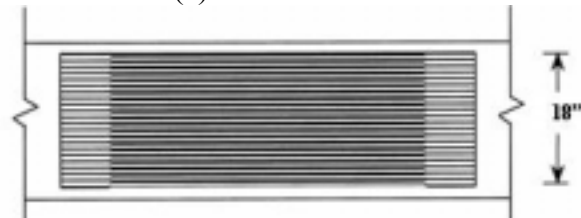
Figure 3.2. Two-Ply CFRP Laminate

(a) Elevation View

(b) Plan View

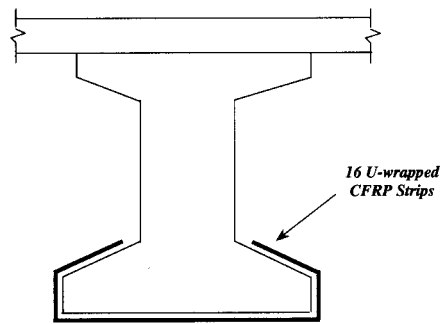
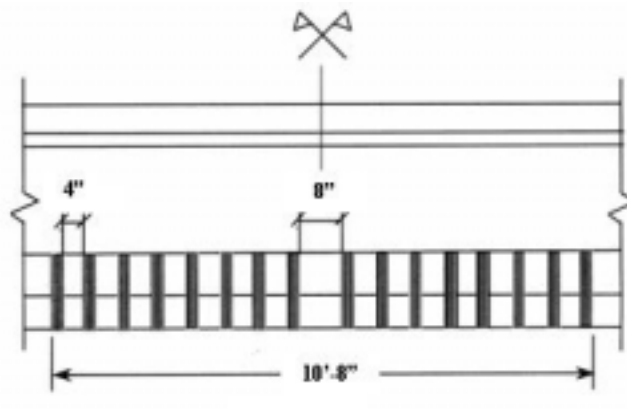
Figure 3.3. CFRP Strips U-Wrapped around the Girder Flange

(a) Elevation View

(b) Plan View

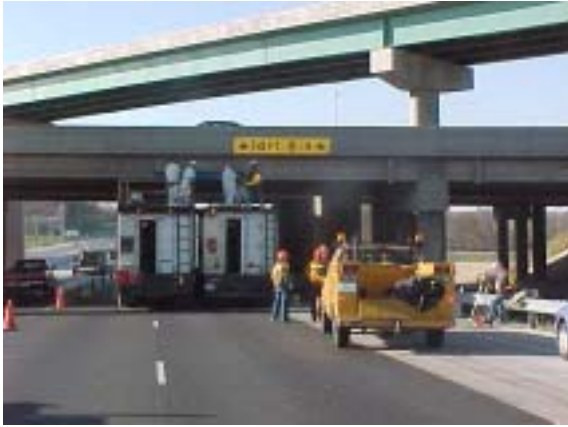
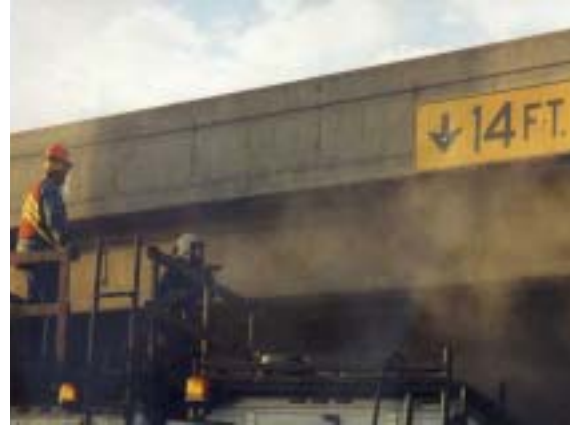
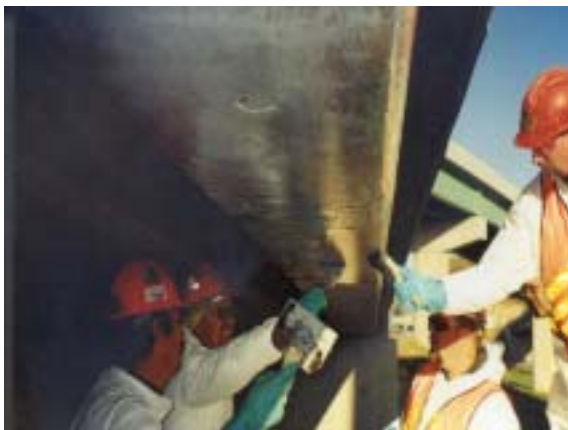
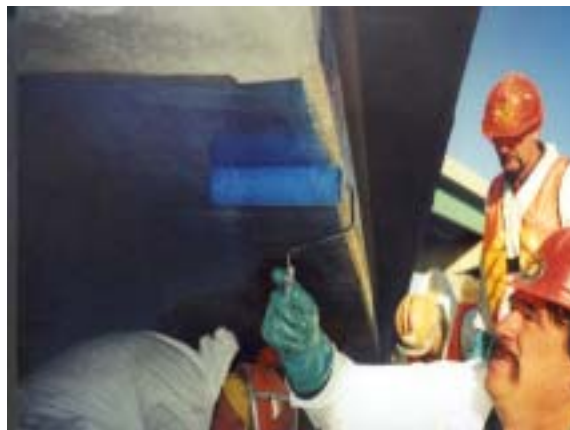
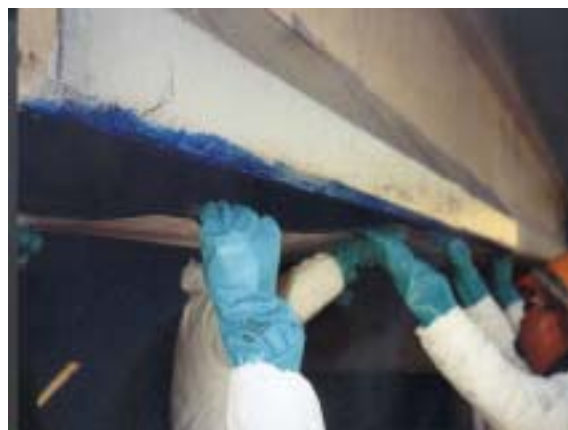
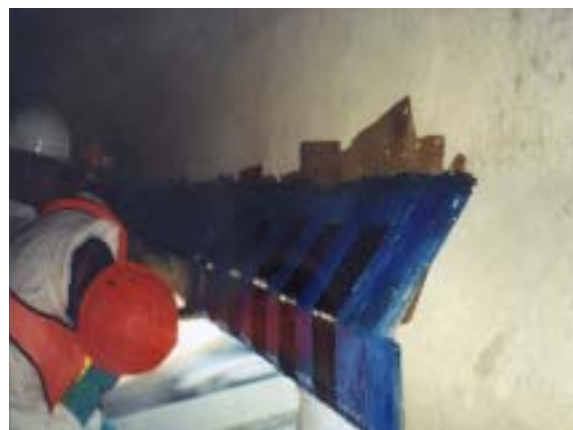
Figure 4.1. Installation Crew at Work

Figure 4.1 illustrates the MoDOT crew at work. The installation of the FRP systems, including surface preparation, was performed in two hours.

(a) Overall View

(b) Surface Sandblasting

(c) Application of Putty

(d) Application of Saturant

(e) Manual Lay-up of CFRP Sheet

(f) Strips Manual Lay-up

***Surface Preparation:*** the bottom edges of the girder were rounded for proper wrapping. Next, the concrete surface was sandblasted until the aggregate was exposed and the surface of the concrete was free of loose and unsound materials.

***Application of second layer of saturant:*** a second layer of saturant was applied and worked into the fibers with a ribbed roller. After this, the second fiber sheet could be installed by repeating the described procedure.

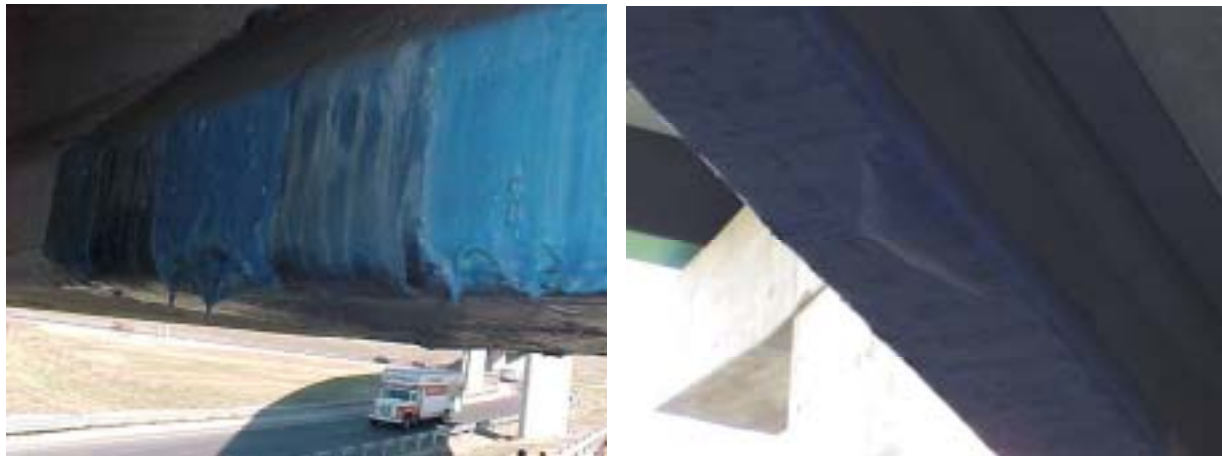
Figure 5.1. Installation Defect

A routine inspection detected a blister in the repaired area. The blister dimensions were 33-in. (83 cm) long, 9.5-in. (24 cm) wide, and 0.75-in (1.9 cm) high. Its formation was caused by the run-off of excess of saturant (see Figure 5.1). Excessive saturant was applied and cross-polymerization did not increase viscosity rapidly enough to prevent flow. No excess saturant should be present on the concrete surface after placement of a fiber sheet. It should be noted that the temperature and weather prior and after installation were within the acceptable ranges. The manufacturer recommends a temperature at installation of 40 °F (4.4 °C), and that the concrete surface was dry.

(a) Excess of Saturant

(b) Blister in the repaired area

Excess of saturant used to impregnate the reinforcing fibers caused the formation of a blister in the repaired area. Thereby, prescriptive installation procedures need to be strictly followed to ensure a good performance of the FRP reinforcement.

It was recommended to epoxy-inject the bubble at the time of painting of the FRP repair. UMR provided required material and assisted a MoDOT maintenance crew in this effort.

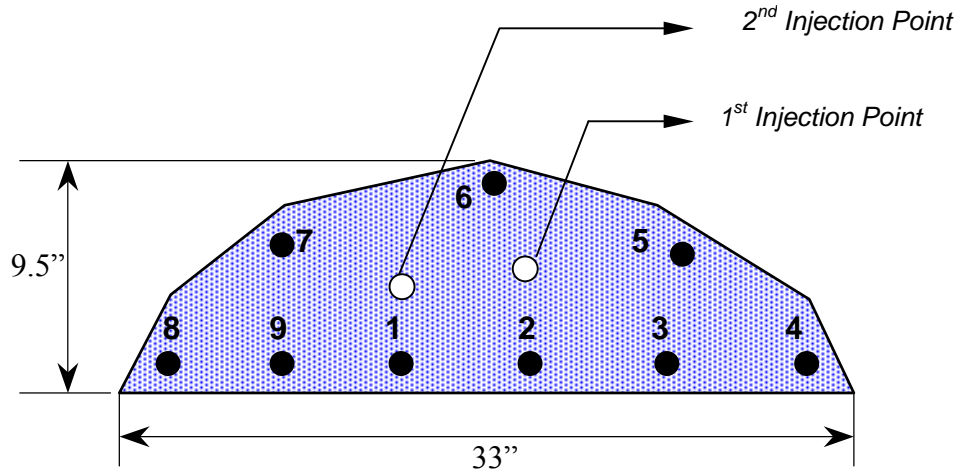
Figure 5.2. Outlet Layout

One lane of traffic on highway I-44 at the intersection of highway I-270 was closed for the injection of blister. A crew from MoDOT first cleaned the surface of FRP laminate where the blister was located. After marking the first injection point at the center of blister and 9 outlets around its edge (see Figure 5.4), the drilling of marked points was executed. No water and obstruction were found in the blister.

Through the first injection point a general purpose gel epoxy adhesive was used to inject the blister. Once the epoxy started to flow through outlets 1 to 6, these were taped. To complete the blister injection, a second injection point was then determined and drilled, the epoxy in this case flow through outlets 7, 8, and 9. All holes were taped when the injection was completed. Then the surface of entire patch where FRP reinforcement was applied was cleaned up and tapes on the blister were removed when epoxy adhesive was set. The entire patch was then painted with two coats of a polymer-based coating. After the protective coating was set, three red lines were marked on the top coat at the edge of outlets 5, 6, and 5 as the reference of any further blister growth. Figure 5.3 illustrates the aforementioned process.

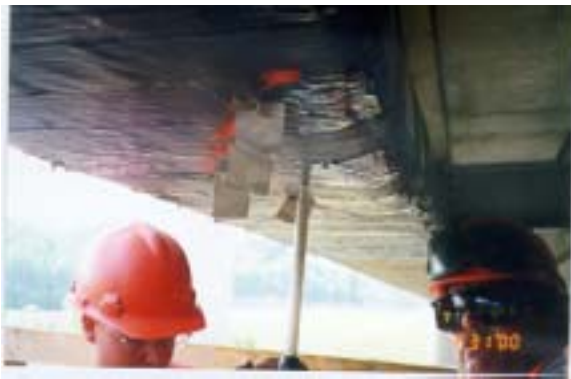
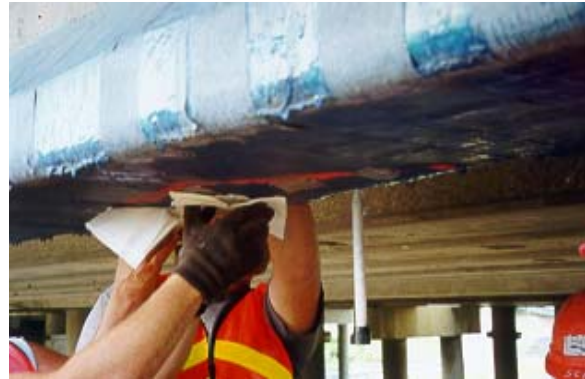
Figure 5.3. Repair of the Installation Defect

(a) Injection of Blister

(b) Coating

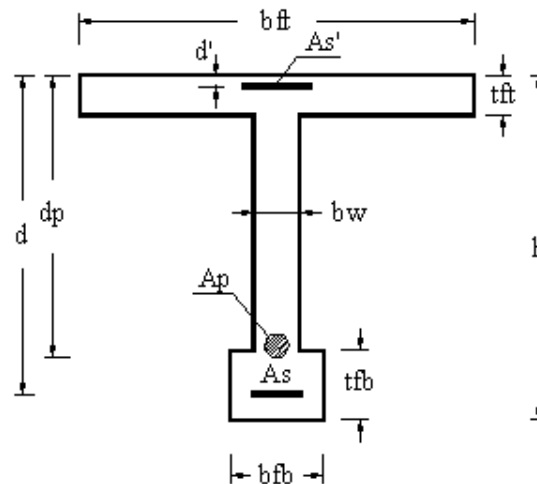
Refer to the following figure

#### Section Dimensions

$h := 39.5$       Total section height, [in] or [mm]  
 $bw := 8$       Width of web, [in] or [mm]  
 $bft := 38.8$       Width of top flange (zero for rectangular sections), [in] or [mm]  
 $tft := 9.3$       Thickness of top flange (zero for rectangular sections), [in] or [mm]  
 $bfb := 19$       Width of bottom flange (zero for rectangular or T sections), [in] or [mm]  
 $tfb := 8$       Thickness of bottom flange (zero for rectangular or T sections), [in] or [mm]

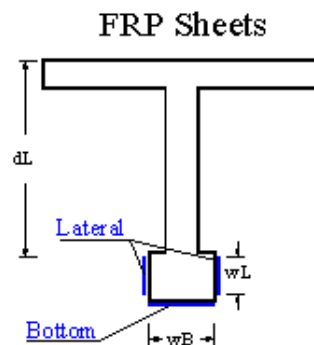
Refer to the following figure

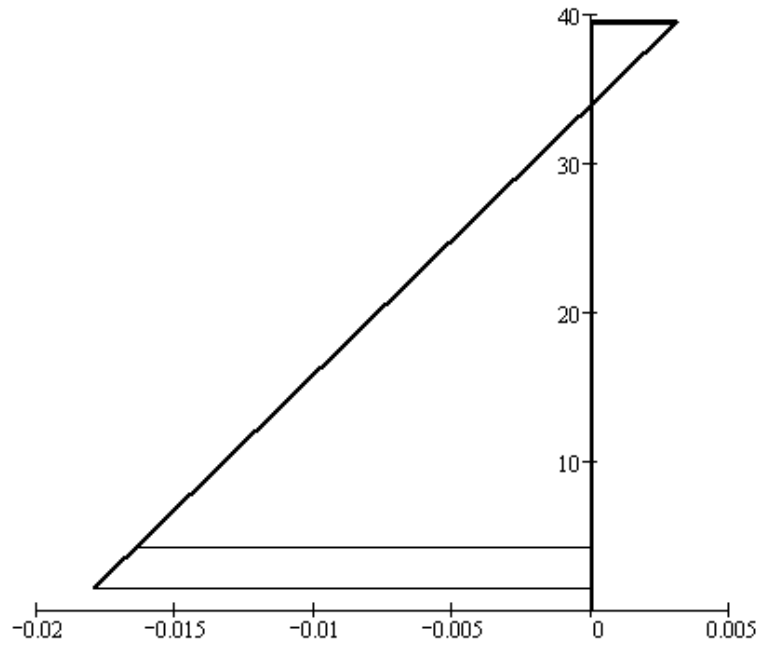
$$\phi M_n = 2237.2$$

Design moment capacity [k-ft] or [kN-m]

Failure\_Mode = "Concrete Crushing"

$c_b = 2.151$  Depth to the neutral axis for balanced failure, [in] or [mm]

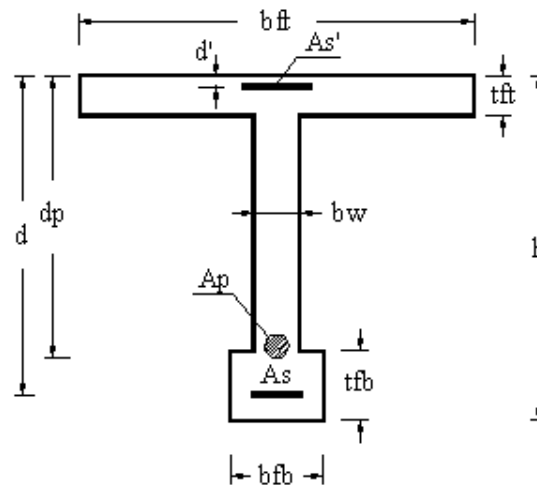
Refer to the following figure

#### Section Dimensions

$h := 39.5$	Total section height, [in] or [mm]
$b_w := 8$	Width of web, [in] or [mm]
$b_{ft} := 38.8$	Width of top flange (zero for rectangular sections), [in] or [mm]
$t_{ft} := 9.3$	Thickness of top flange (zero for rectangular sections), [in] or [mm]
$b_{fb} := 19$	Width of bottom flange (zero for rectangular or T sections), [in] or [mm]
$t_{fb} := 8$	Thickness of bottom flange (zero for rectangular or T sections), [in] or [mm]

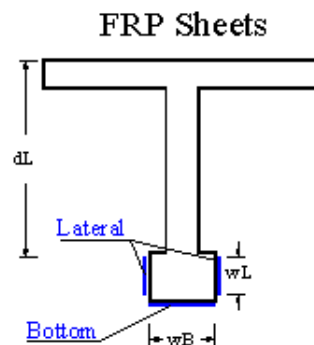
Refer to the following figure

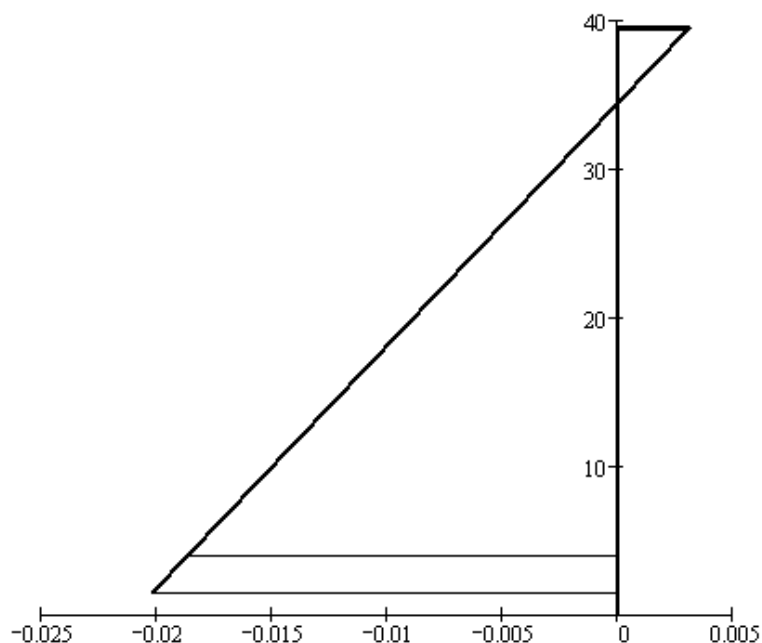
$\phi M_n = 2047.5$

Design moment capacity [k-ft] or [kN-m]

Failure\_Mode = "Concrete Crushing"

$c_b = 2.151$  Depth to the neutral axis for balanced failure, [in] or [mm]

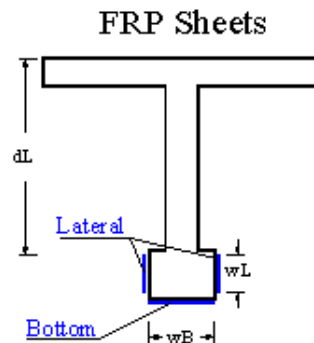
Refer to the following figure

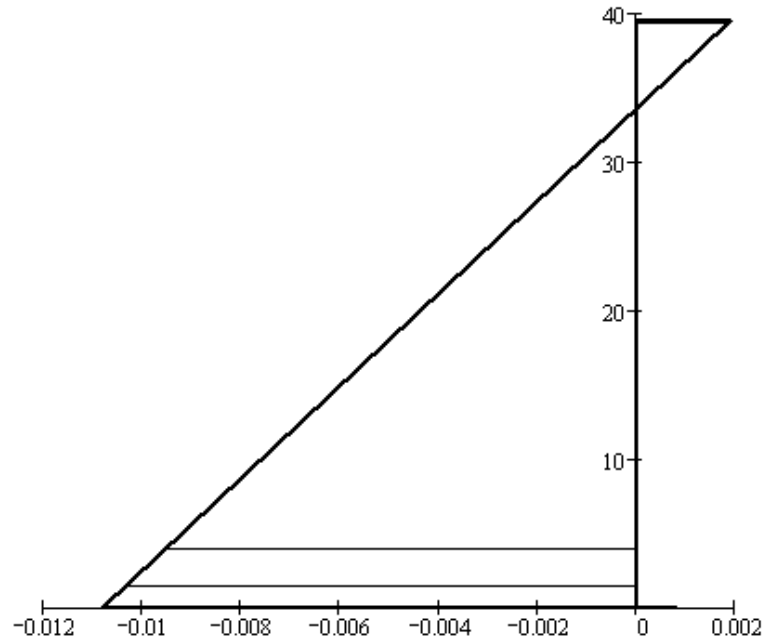
$\phi M_n = 2222.7$

Design moment capacity [k-ft] or [kN-m]

Failure\_Mode = "Tension Controlled"

$c_b = 8.572$  Depth to the neutral axis for balanced failure, [in] or [mm]
